SAN FERNANDO, CALIFORNIA,
EARTHQUAKE OF
9 FEBRUARY 1971

GORDON B. OAKESHOTT, *Editor*
CALIFORNIA DIVISION OF MINES AND GEOLOGY

BULLETIN 196
California Division of Mines and Geology
Resources Building, Sacramento, California

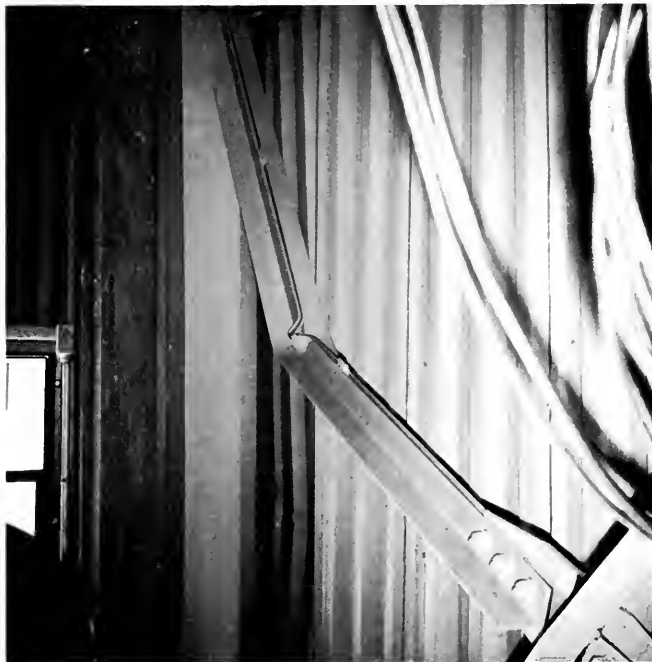
The chemical building sustained failures of structural-steel members (photo 15). The service-center building had fairly severe cracking and spalling at wall-to-floor connections, particularly where the two wings of the building connect.

Photo 15. Joseph Jensen Filtration Plant chemical building. Buckled steel bracing member.

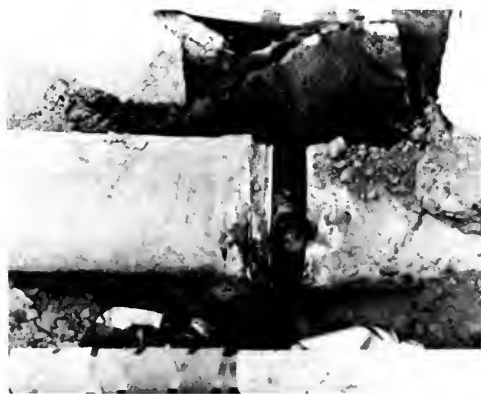
Photo 16. Eighteen-inch diameter steel water pipe, concrete lined. Joint opened by tension. Note recently repaired gas main in foreground. Los Angeles Department of Water and Power photo.

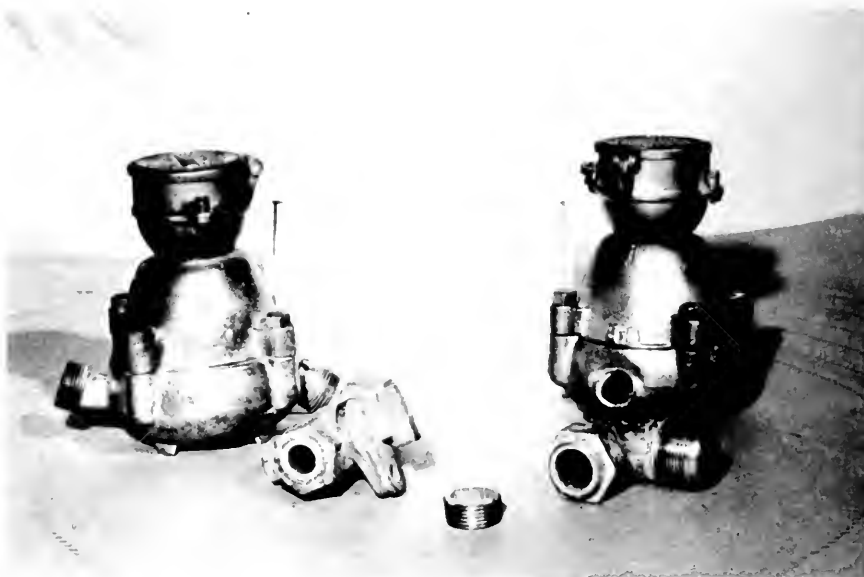
Photo 17. Water meters broken in earthquake. Los Angeles Department of Water and Power photo.

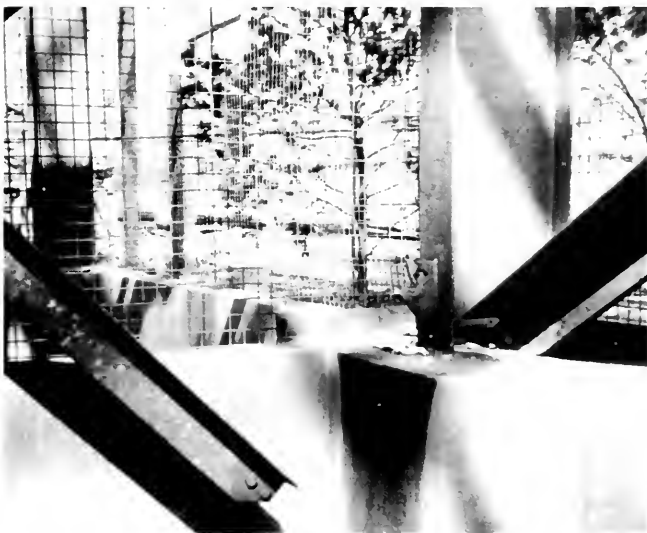
Photo 19. Sylmar Converter Station, radio interference structure. Broken diagonal bracing connection.

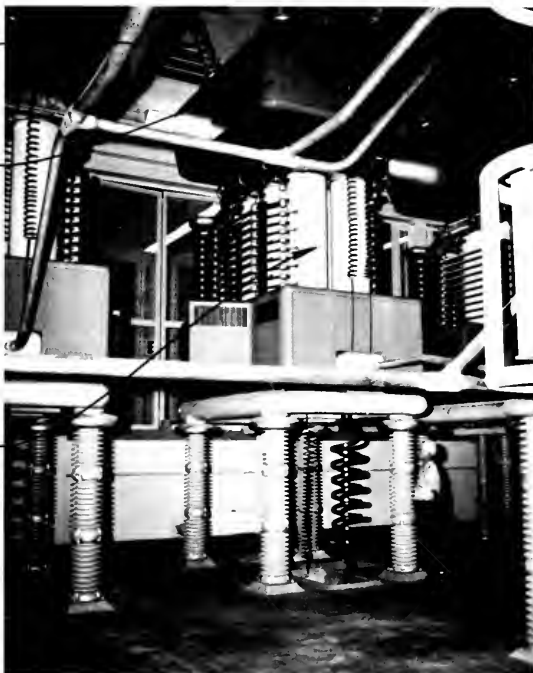
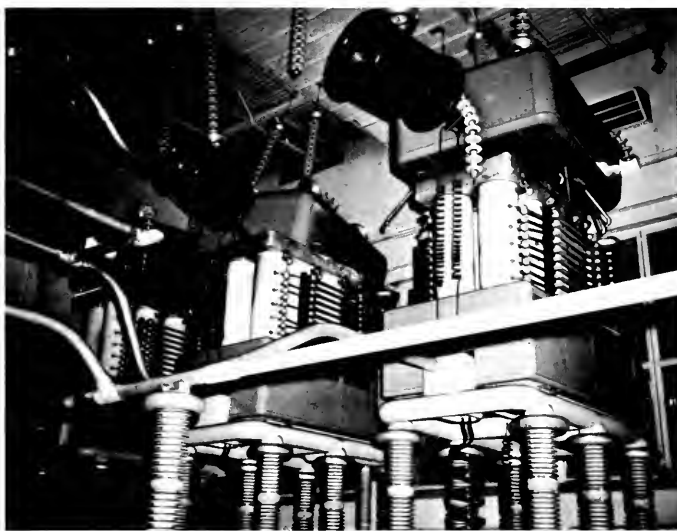
Photo 22. Sylmar Converter Station, valve hall. Picture taken after earthquake, showing broken insulators which supported current dividers. Note damage to electrical connections between current dividers and valves below. Los Angeles Department of Water and Power photo.

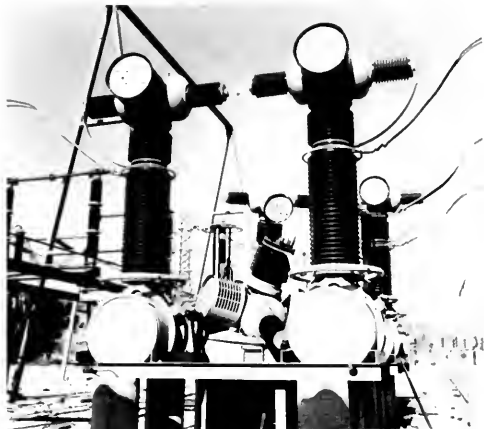
Photo 23. Sylmar Converter Station. Pneumatic circuit breakers. Two relatively undamaged units in foreground. Los Angeles Department of Water and Power photo.

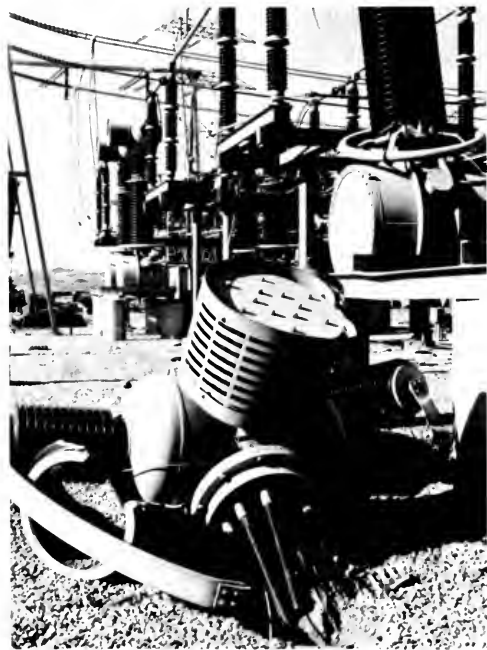
Photo 24. Sylmar Converter Station. Head of pneumatic circuit breaker. Note broken wooden rods in foreground. Los Angeles Department of Water and Power photo.

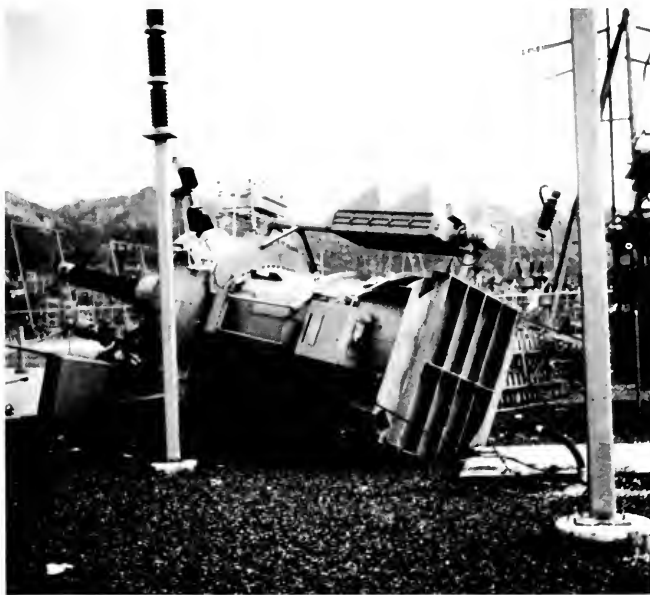
Photo 25. Sylmar Converter Station. Harmonic filter fell over. Anchorage to foundations failed.

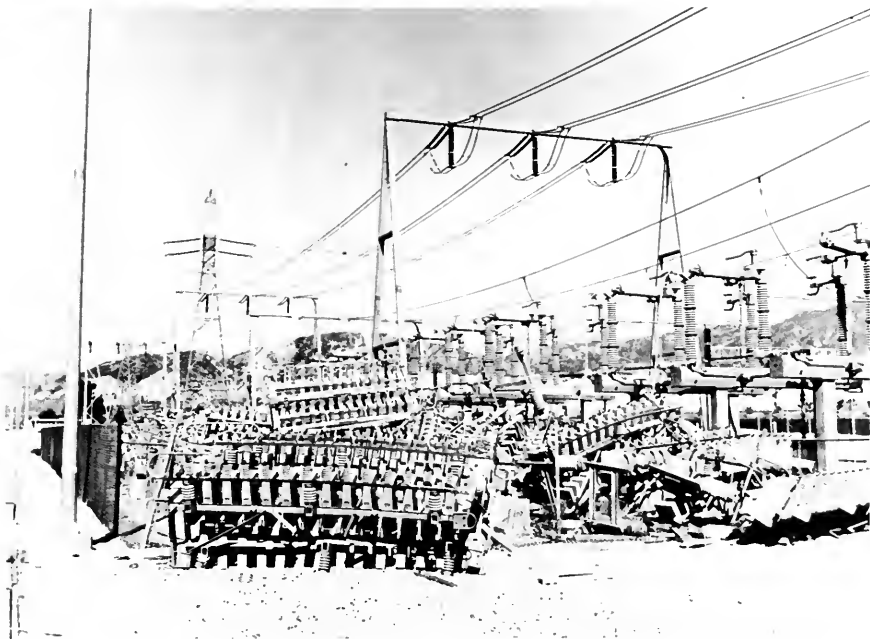
Photo 26. Sylmar Converter Station. Toppled filter capacitor banks. *Las Angeles Department of Water and Power photo.*

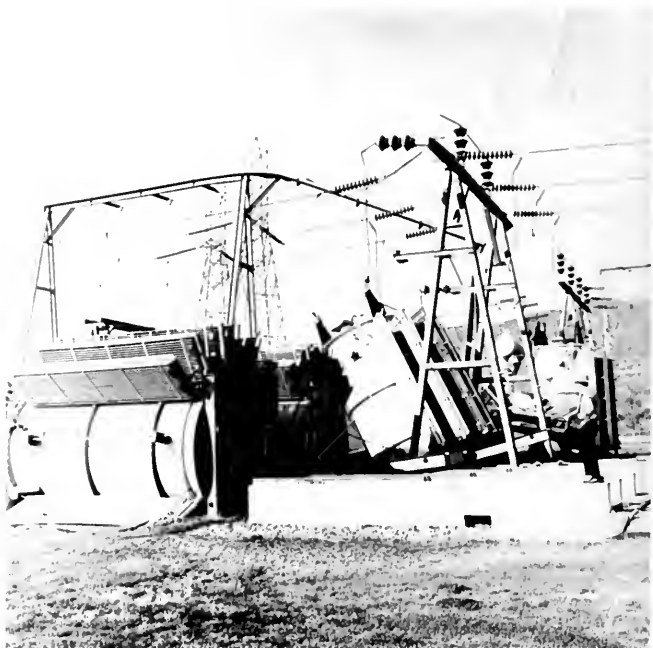
The Olive Switching Station (LADWP), located half a mile east of the Sylmar Converter Station (figure 1), was put out of service totally. Seven transformers toppled on their sides, and other equipment was severely damaged (photo 27). The transformers and equipment were not adequately anchored.

Photo 27. Olive Switching Station. Toppled transformers. Los Angeles Department of Water and Power photo.

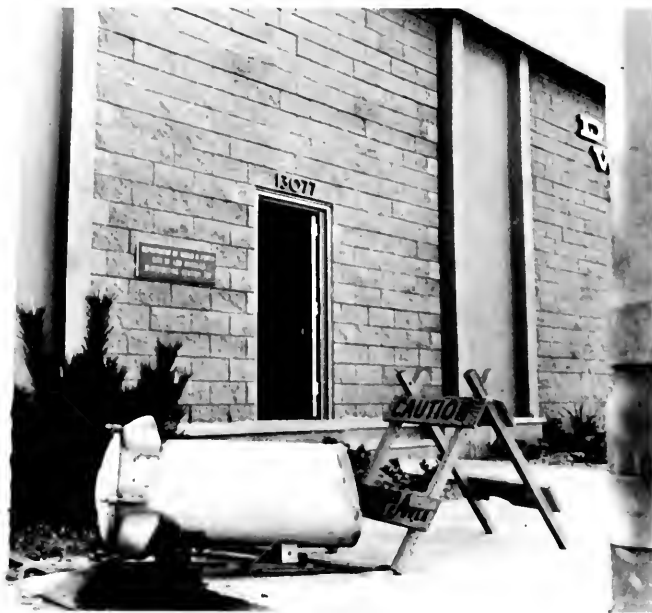
Some 285 small distribution transformers were so damaged as to have to be replaced. These were almost all overhead pole mounted transformers (photo 28). Thirty wood poles required replacement.

Photo 28. Damaged pole-mounted transformer on ground. Los Angeles Department of Water and Power photo.

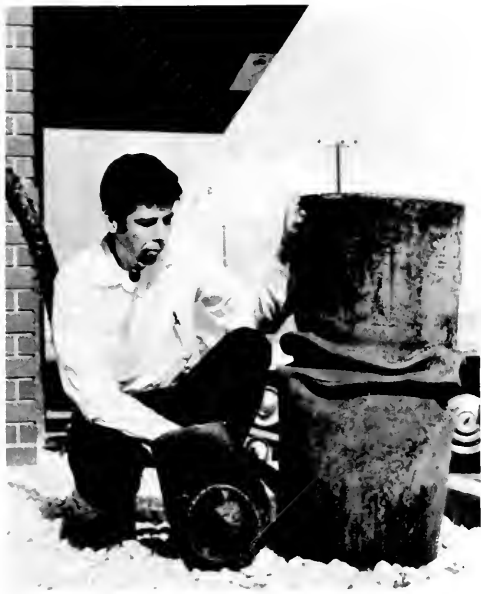
The greatest damage was sustained by a 16-inch transmission line in Foothill Boulevard and Glenoaks Boulevard. In this 6-mile length of pipeline, there were 52 separate breaks (photo 29). Five miles of a 12-inch transmission line have been abandoned between Sylmar and San Fernando due to numerous breaks. Nine breaks occurred in a one-mile length of a 26-inch transmission line in the Sylmar area. Over all, a total of 68 transmission-line breaks were repaired in restoring service. Control of gas flowing through the area was accomplished by closing main-line valves on the affected pipelines except for one break where the leakage was monitored but allowed to continue to prevent additional customer outages. Continuation of supply to the Los Angeles Basin area was also aided by an eight-hour curtailment of large steam-plant loads in the San Fernando Valley area.

Photo 29. Compressive forces buckled 16-inch steel gas pipeline and 10-inch tee. Southern California Edison Company photo.

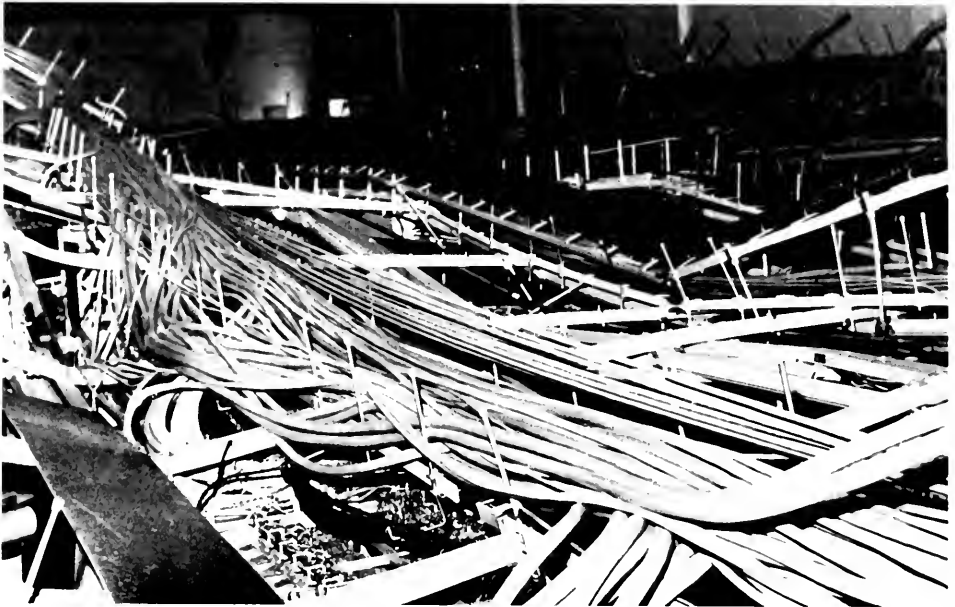
The area affected by this earthquake is served by the Pacific and The General Telephone Companies. The General Telephone Company sustained the worst damage at their Sylmar Central Office. Ninety-five percent of the automatic switching equipment was buckled or bent, lying on the floor or against adjacent frames and/or walls (photo 30). This damage was caused by the heavy shaking and inadequate anchorage of the equipment to the building.

Photo 30. Sylmar Central Office. Collapsed automatic telephone switching equipment. *General Telephone Company photo.*

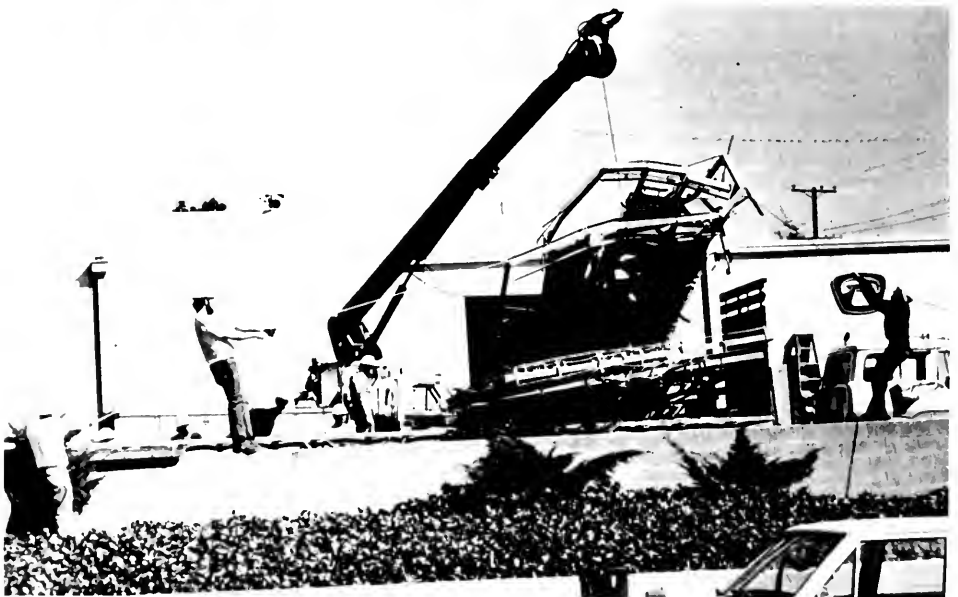
Photo 31. Sylmar Central Office. Collapsed automatic telephone switching equipment being removed from building. *General Telephone Company photo.*

To speed repairs, the damaged equipment was removed completely from the building (photo 31).
